INDOOR AIR QUALITY ASSESSMENT

**Greenwood Elementary School
1030 Main Street
Wakefield, Massachusetts**

Prepared by:
Massachusetts Department of Public Health
Bureau of Environmental Health Assessment
January 2003

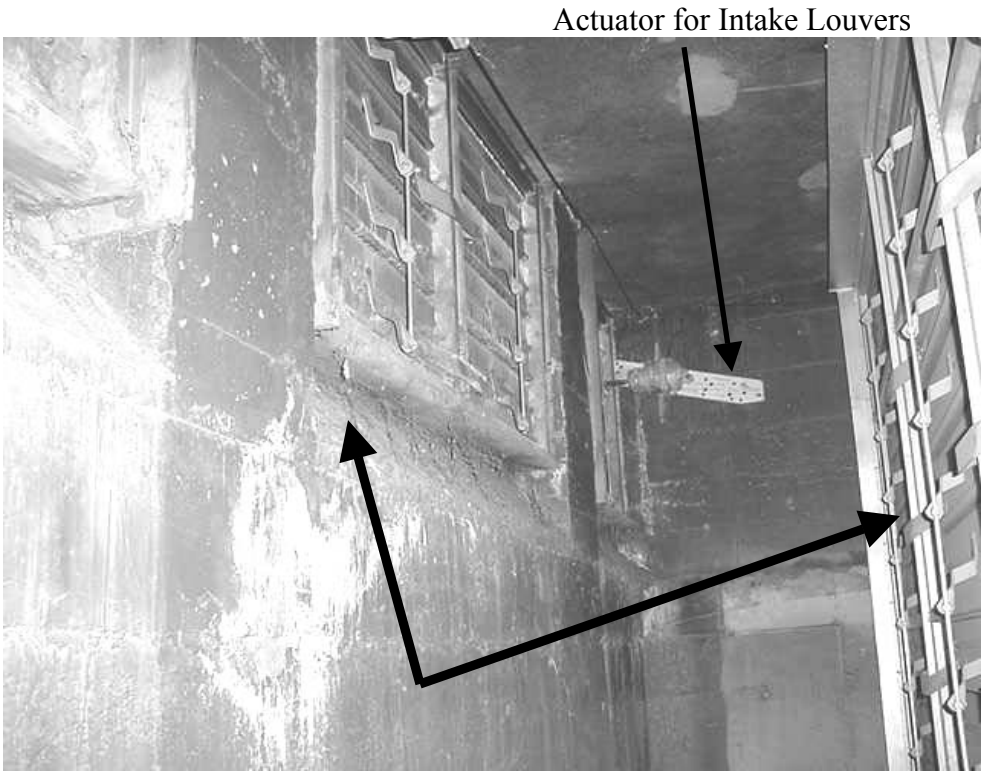
Picture 1

Fresh air was originally provided by an air handling unit (AHU) located in a large room on the ground floor that is connected to ductwork leading to air diffusers. Fresh air is drawn into the building through a louvered vent in the basement (see Picture 1). Air is drawn through heating elements into a fan unit that distributes the air via wall mounted fresh air grilles in classrooms (see Pictures 2-4). Classroom fresh air supply grilles are connected to the fan unit by ductwork located in the basement. This ventilation system appears to have been abandoned as part of an energy conservation project based on the following observations:

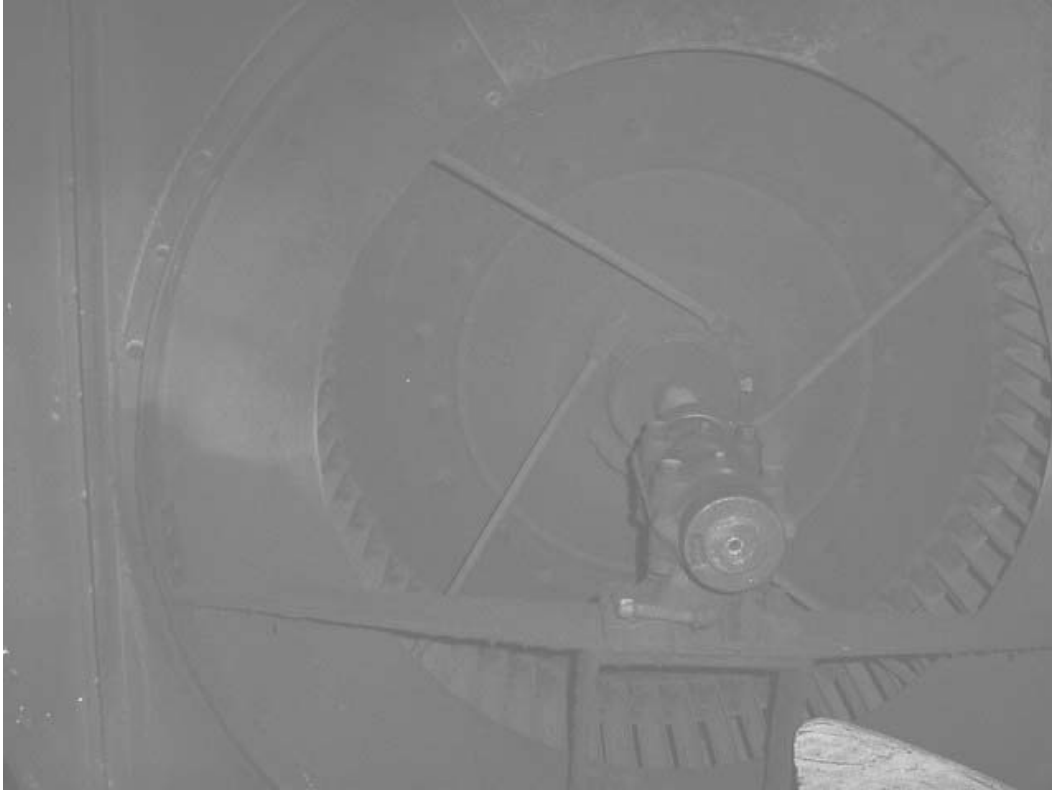
Picture 2

Large Ventilation Fan In Basement

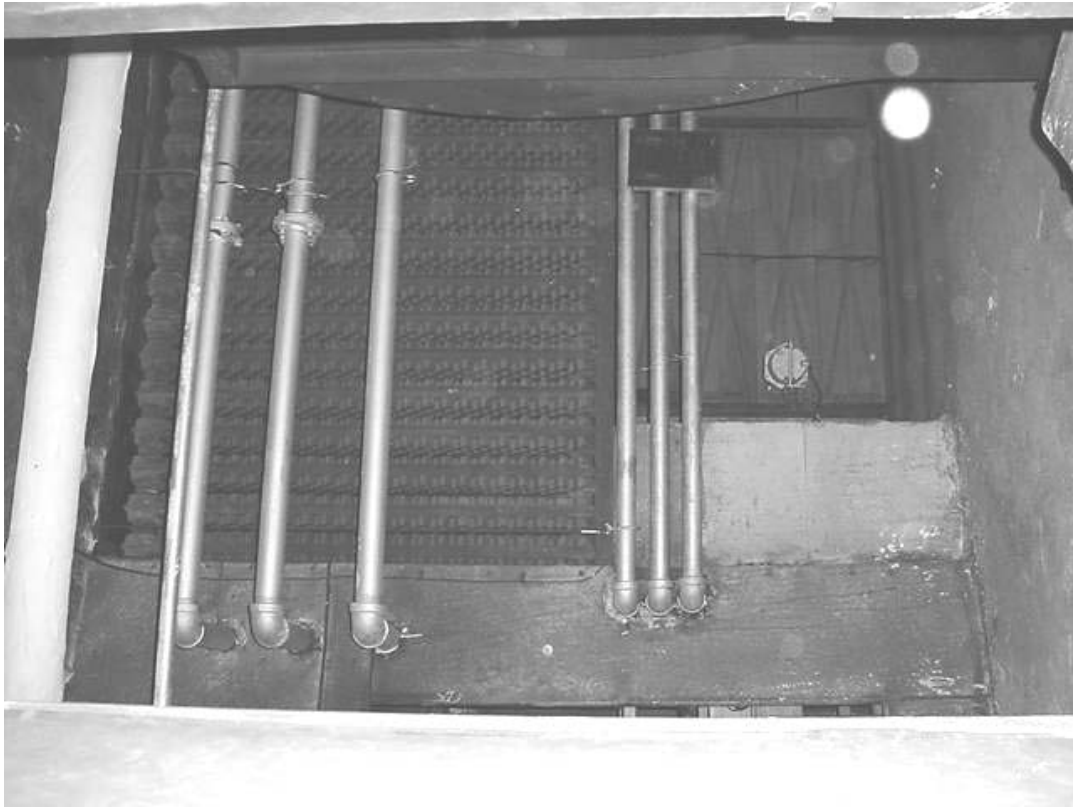
Picture 3

View of Heating Elements and Steam Pipes Taken “Up” The Ventilation Shaft in the Basement

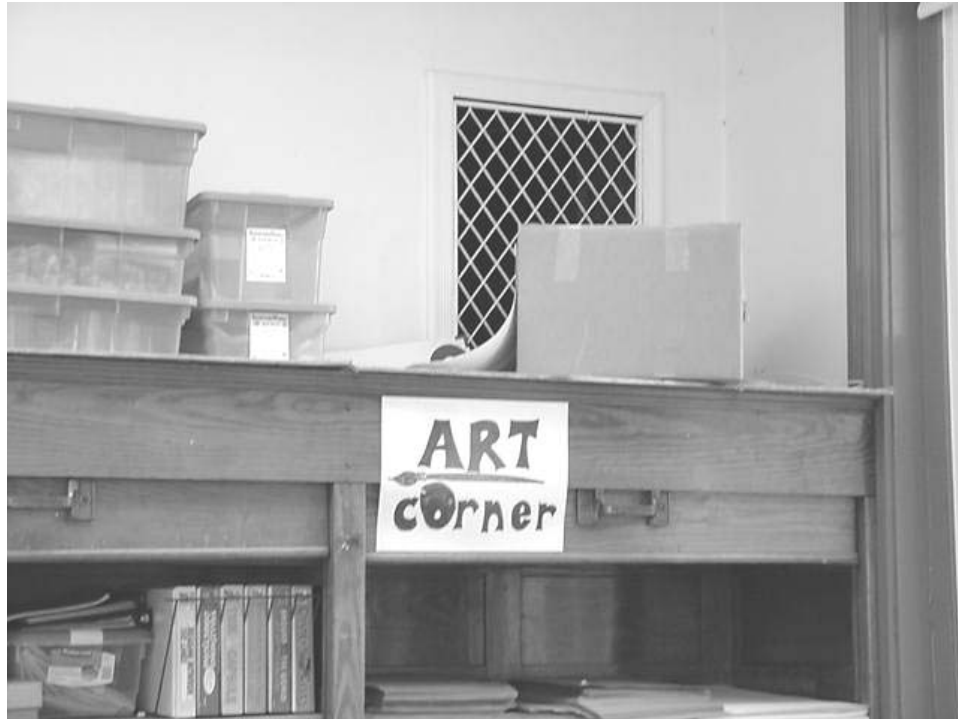
Picture 4

Grated Supply Vent for Ventilation System

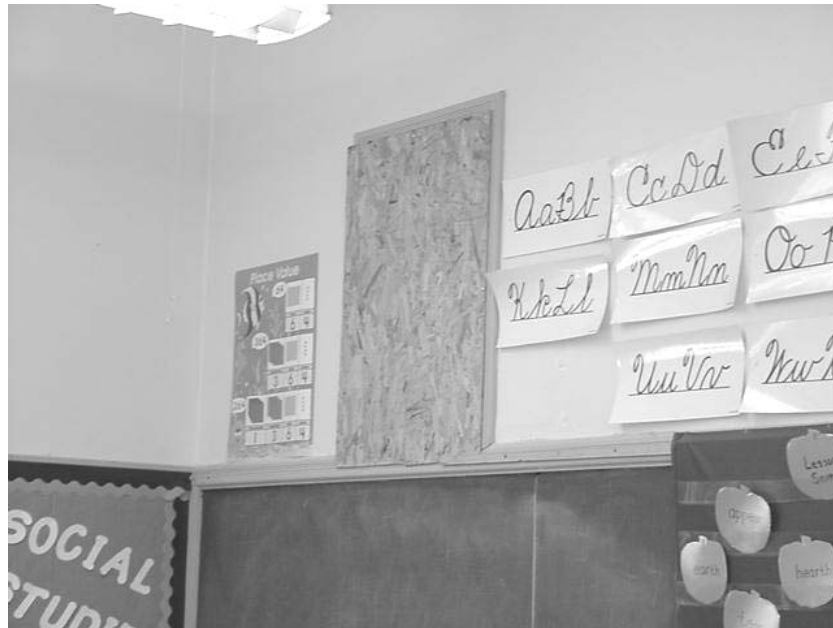
Picture 5

1. A number of fresh air intakes were sealed with plywood (see Picture 5).
2. The fresh air intakes on the exterior wall as well as for the AHU were shut and actuators, which controlled airflow, were removed (see Pictures 1 & 6).
3. The fan belt connected to the motor that drives the fan unit was removed (Picture 7).

Classroom Supply Vent Sealed With Plywood

3. As recommended by ATC, if original mechanical ventilation systems are not fully restored, ensure abandoned exhaust and supply vents are properly sealed in classrooms, the basement and on the roof to eliminate pathways for movement of odors and particulates into occupied areas.

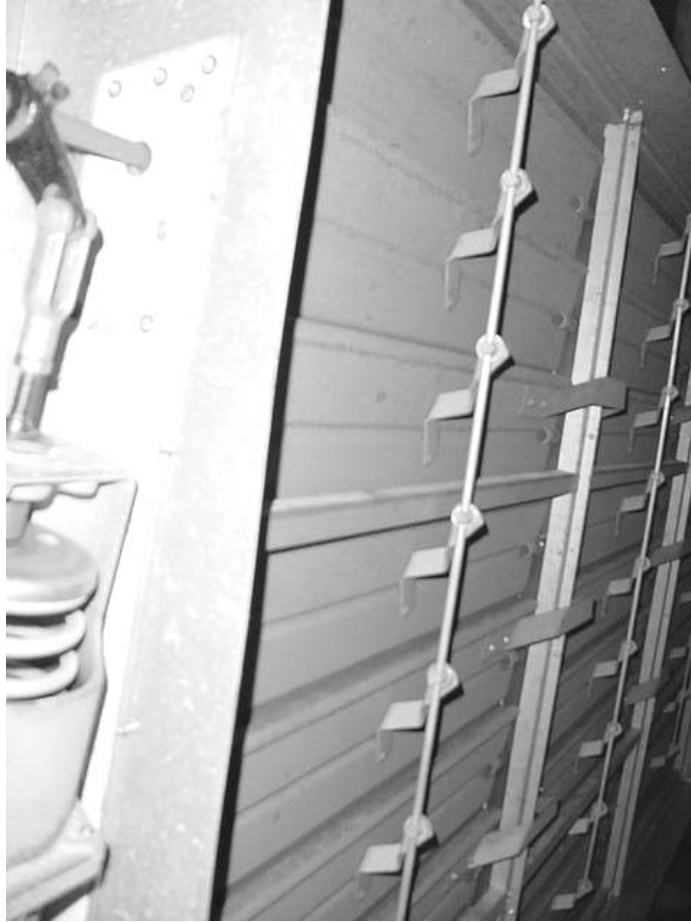
Picture 6

AHU Air Intake Shut

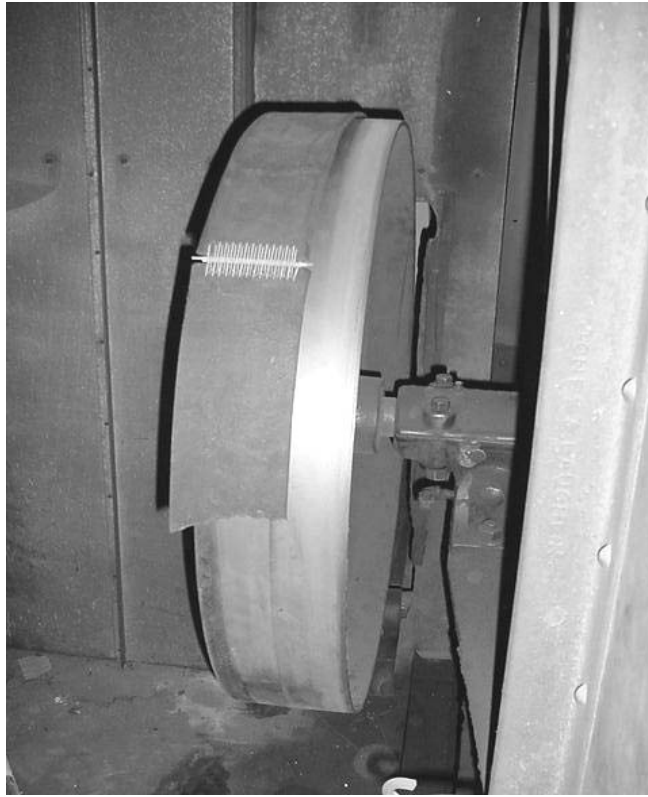
Picture 7

Remnants of Fan Belt on Mechanical Ventilation System Flywheel

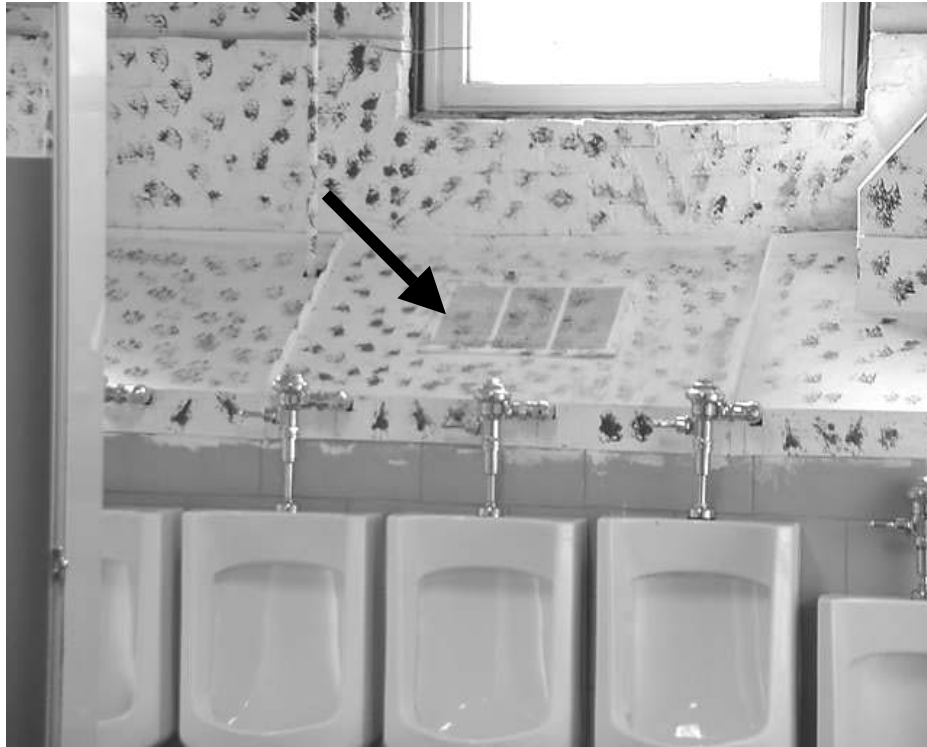
Picture 8

Exhaust Vent Duct for Restroom

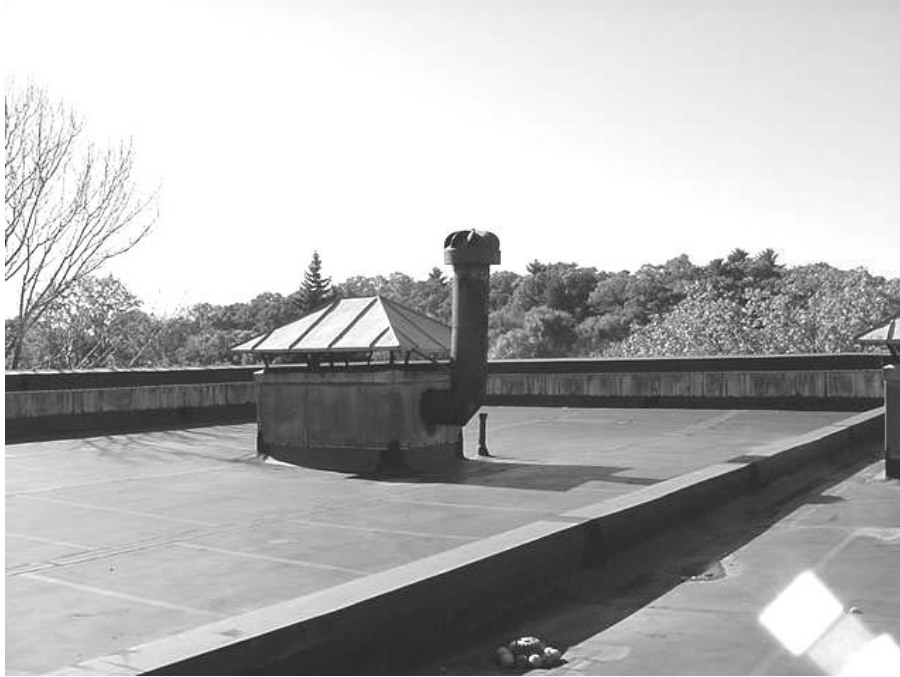
Turbine Fan for Restroom Exhaust Vent Picture 9

1. Seal all open pipes in the space behind the urinals.
2. Repair the turbine vent on the roof. Consider replacing the turbine vent with a motorized exhaust ventilation fans to remove odors from the basement boy's restroom.

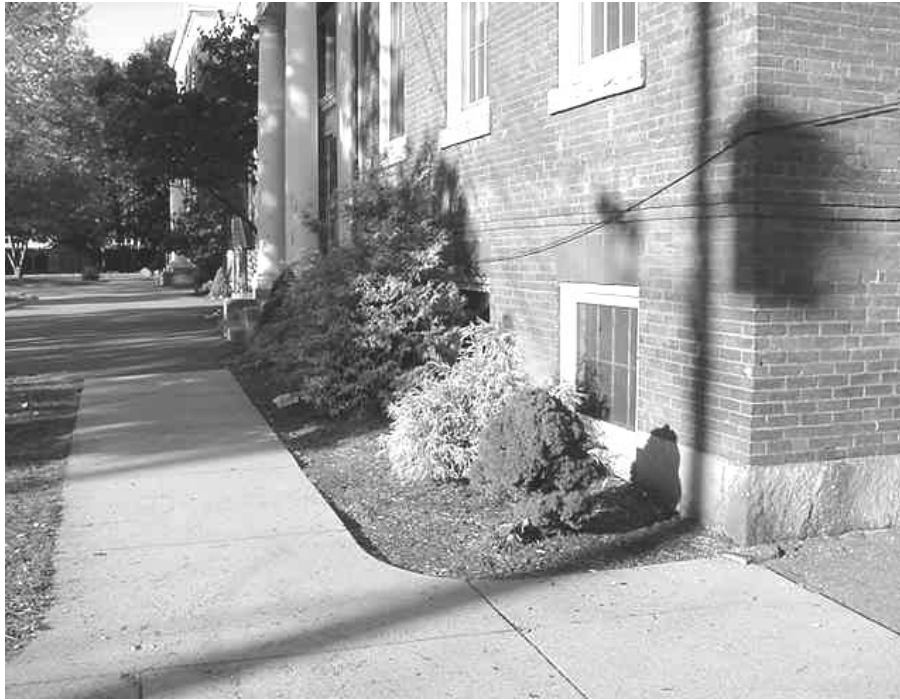
Picture 11

Shrubbery exists in close proximity to the foundation walls (see Picture 11). The growth of roots against the exterior walls can bring moisture in contact with wall brick and eventually lead to cracks and/or fissures in the foundation below ground level. Over time, this process can undermine the integrity of the building envelope and provide a means of water entry into the building through capillary action through foundation concrete and masonry (Lstiburek, J. & Brennan, T.; 2001).

Shrubbery in Close Proximity to the Foundation Wall

7. Move foliage to no less than five feet from the foundation.
8. Consider discontinue the use of tennis balls on chairs to prevent latex dust generation.
9. Seal utility holes and repair/replace the corroded access plate in the boy's restroom, to prevent the egress of dirt, dust and particulate matter into occupied areas.
10. Consider installing local exhaust ventilation in photocopier room.

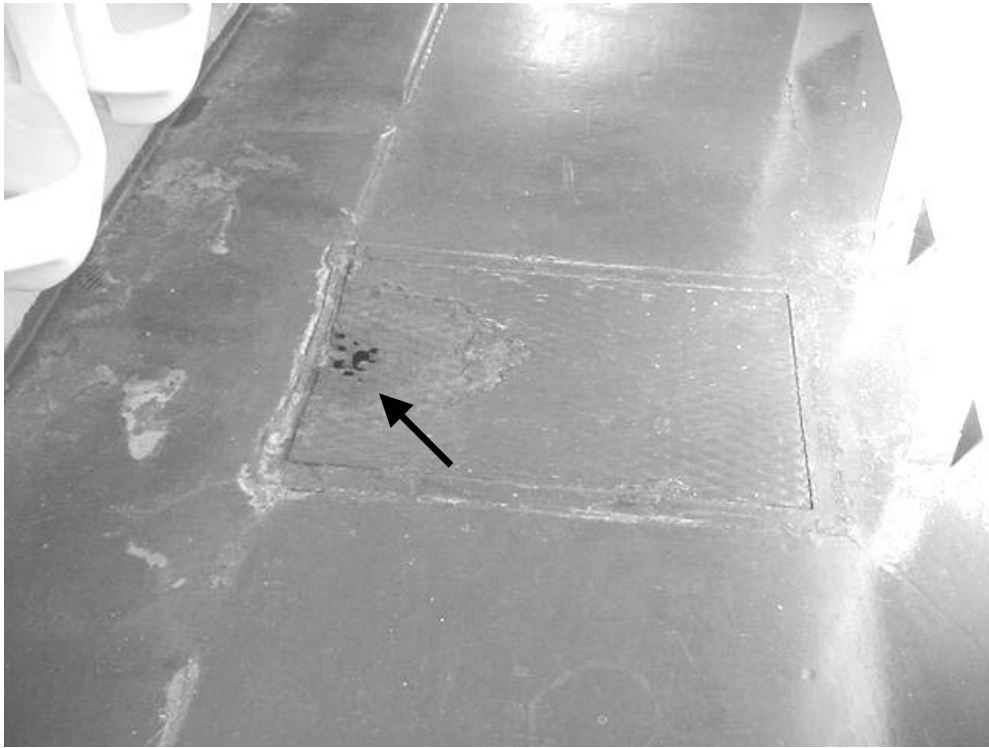
Picture 12

Several other conditions were noted during the assessment, which can affect indoor air quality. The abandoned ventilation system can also serve as a pathway for basement particulates and odors to migrate into occupied areas of the building. Holes in walls and ceilings may also serve as pathways for particulates. In general, cold air migrates to areas with heated air, thereby creating drafts. The temperature in the heating coil room will generally be lower than the occupied areas of classrooms, therefore colder basement air will move to classrooms via the vent system if means of access (holes, open access doors) exist in the ductwork. In this instance, pathways for basement air, odors and particulate matter exist. Also observed were open utility holes and a corroded access plate to the crawlspace in the boy's restroom (see Picture 12). These breaches can also serve as additional sources of particulates and odors.

Corroded Hole in Crawlspace Access Panel in Restroom

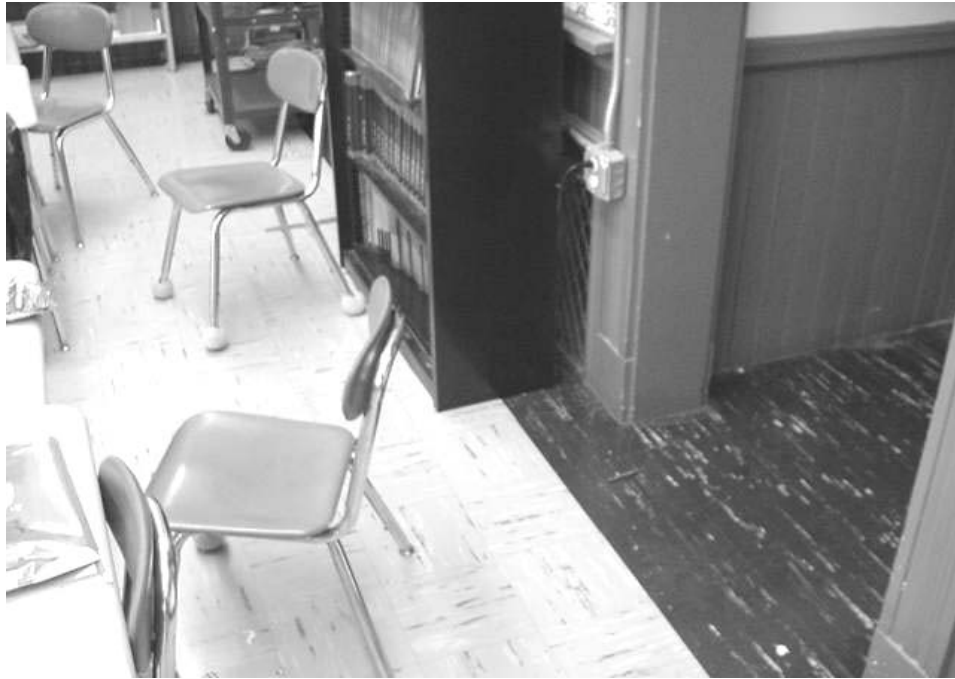
Picture 13

In an effort to reduce noise from sliding chairs, tennis balls are sliced open and placed on chair legs (see Picture 13). Tennis balls are made of a number of materials that are a source of respiratory irritants. Constant wearing of tennis balls can produce fibers and to off-gas VOCs. Tennis balls are made with a natural rubber latex bladder, which becomes abraded when used as a chair leg pad. Use of tennis balls in this manner may introduce latex dust into the school environment. Some individuals are highly allergic to

Tennis Balls on Chairs

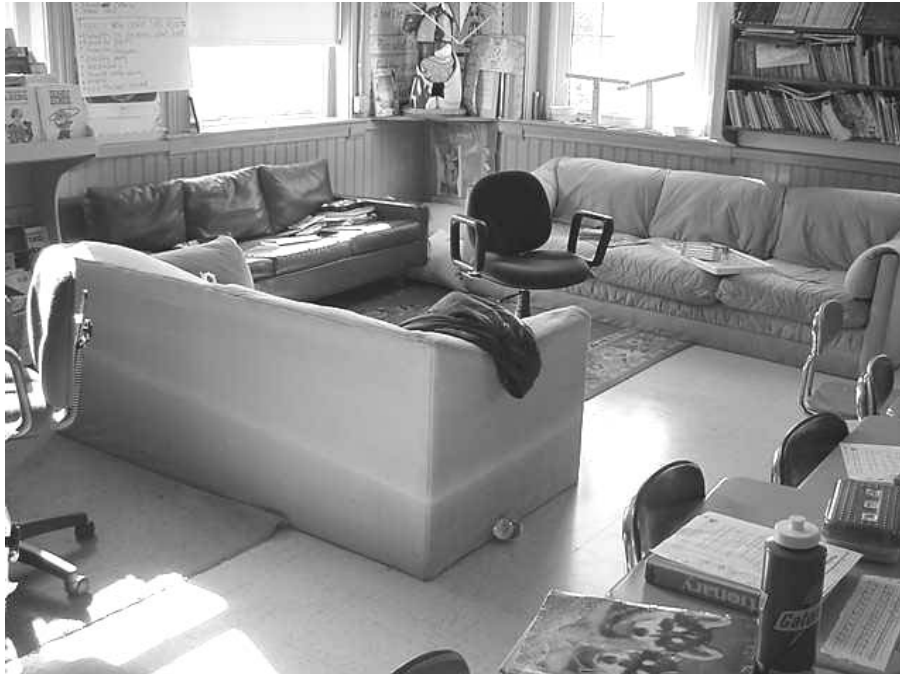
Picture 14

A number of classrooms contained upholstered furniture (see Picture 14). Upholstered furniture is covered with fabric that comes in contact with human skin. This type of contact can leave oils, perspiration, hair and skin cells. Dust mites feed upon human skin cells and excrete waste products that contain allergens. In addition, if relative humidity levels increase above 60 percent, dust mites tend to proliferate (US EPA, 1992). In order to remove dust mites and other pollutants, frequent vacuuming of upholstered furniture is recommended (Berry, M.A., 1994). It is also recommended that upholstered furniture (if present in schools), be professionally cleaned on an annual basis or every six months if dusty conditions exist outdoors (IICR, 2000).

Upholstered Furniture in Classrooms
